# Army Lodging Wellness Recommendation

## Fort Drum - Final Submittal

August 18, 2003

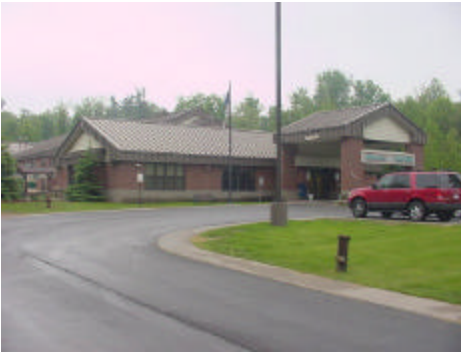
Building P-4205, constructed in 1988, is a 2-story structure housing 45 standard rooms at 324 square feet each, 64 extended stay rooms without a full kitchen at 384 square feet each and 2 extended stay rooms without a full kitchen at 432 square feet. The building is in good condition and meets the majority of current Army Lodging standards. The cost to make improvements will not exceed 50% of the replacement cost.

Our recommendation is to retain building P-4205 in the Fort Drum Lodging inventory. This facility will remain in the Fort Drum Wellness Solution and Lodging Master Plan.

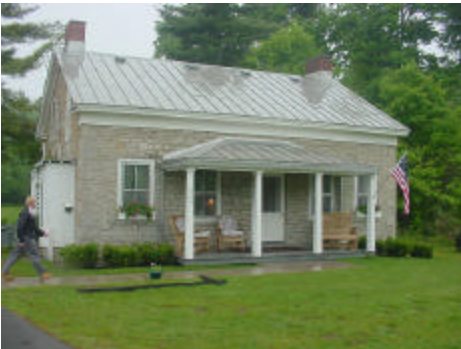
### ***Lodging Building P-4700 “The Caretaker’s House”***

Building P-4700, constructed in 1830, is a historic 2-story structure housing one DVQ room with a full kitchen at 2,055 square feet. The building is in good condition but does not meet current Army Lodging standards. The cost to make improvements and bring this facility up to Army Lodging standards will exceed the 50% replacement cost.

Our recommendation is to remove building P4700 from the Lodging inventory, allowing the installation to determine an alternate use for the facility. This facility will be removed from the Fort Drum Wellness Solution and Lodging Master Plan.

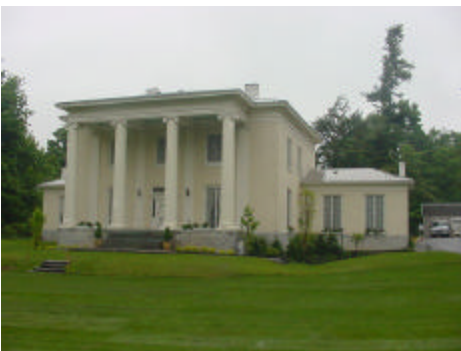
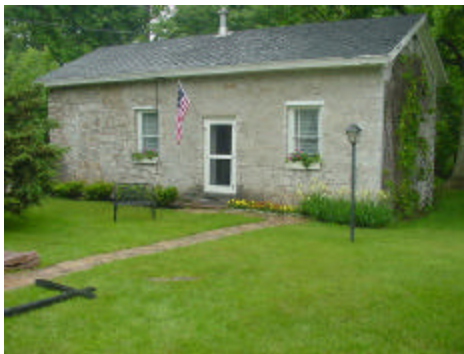
### ***Lodging Building P-4701 “The LeRay Mansion”***

Building P-4701, constructed in 1822, is a 2-story historic structure housing 4 DVQ rooms with a full kitchen at 546 square feet each. The building is in fair condition but does not meet current Army Lodging standards. The cost to make improvements and bring this facility up to Army Lodging standards will exceed the 50% replacement cost.

Our recommendation is to remove building P4701 from the Lodging inventory, allowing the installation to determine an alternate use for the facility. This facility will be removed from the Fort Drum Wellness Solution and Lodging Master Plan.

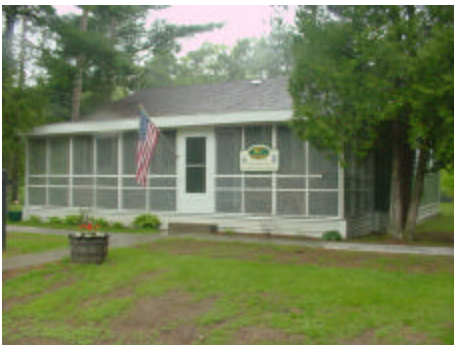
### ***Lodging Building P-4702***

Building P-4702, constructed in 1822, is a single story historic structure housing one DVQ room with a full kitchen at 800 square feet. The building is in fair condition but does not meet current Army Lodging standards. The cost to make improvements and bring this facility up to Army Lodging standards will exceed the 50% replacement cost.

Our recommendation is to remove building P4702 from the Lodging inventory, allowing the installation to determine an alternate use for the facility. This facility will be removed from the Fort Drum Wellness Solution and Lodging Master Plan.

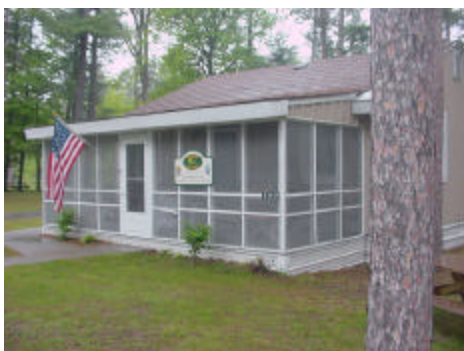
### ***Lodging Building T-2251***

Building T-2251, constructed in 1944, is a single story structure housing one single room without a full kitchen at 969 square feet. The building is in fair condition but does not meet current Lodging size standards. The cost to make improvements and bring up this building up to Army Lodging standards will exceed the 50% replacement cost.

Our recommendation is to remove building T-2251 from the Lodging inventory, allowing the installation to determine an alternate use for the facility. This facility will be removed from the Fort Drum Wellness Solution and Lodging Master Plan.

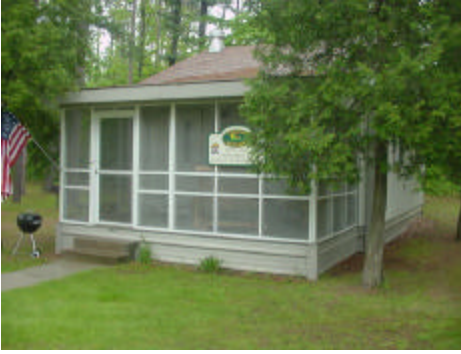
### ***Lodging Building T-2252***

Building T-2252, constructed in 1944, is a single story structure housing one family suite with a full kitchen at 969 square feet. The building is in fair condition but does not meet current Lodging size standards. The cost to make improvements and bring up this building up to Army Lodging standards will exceed the 50% replacement cost.

Our recommendation is to remove building T-2252 from the Lodging inventory, allowing the installation to determine an alternate use for the facility. This facility will be removed from the Fort Drum Wellness Solution and Lodging Master Plan.

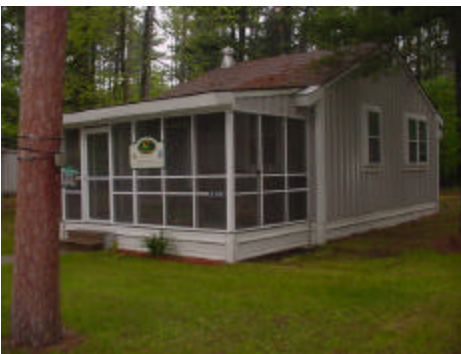
### ***Lodging Building T-2253***

Building T-2253, constructed in 1944, is a single story structure housing a single standard room at 607 square feet. The building is in fair condition but does not meet current Army Lodging standards. The cost to make improvements and bring this facility up to Army Lodging standards will exceed the 50% replacement cost.

Our recommendation is to remove building T-2253 from the Lodging inventory, allowing the installation to determine an alternate use for the facility. This facility will be removed from the Fort Drum Wellness Solution and Lodging Master Plan.

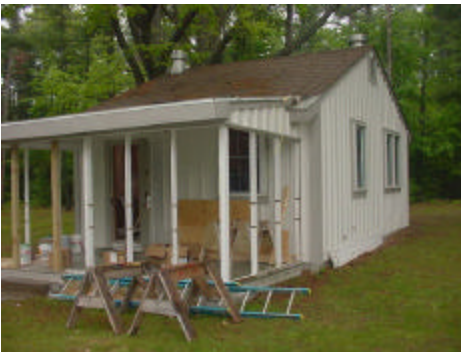
### ***Lodging Building T-2254***

Building T-2254, constructed in 1944, is a single story structure housing a single standard room at 607 square feet. The building is in fair condition but does not meet current Army Lodging standards. The cost to make improvements and bring this facility up to Army Lodging standards will exceed the 50% replacement cost.

Our recommendation is to remove building T-2254 from the Lodging inventory, allowing the installation to determine an alternate use for the facility. This facility will be removed from the Fort Drum Wellness Solution and Lodging Master Plan.

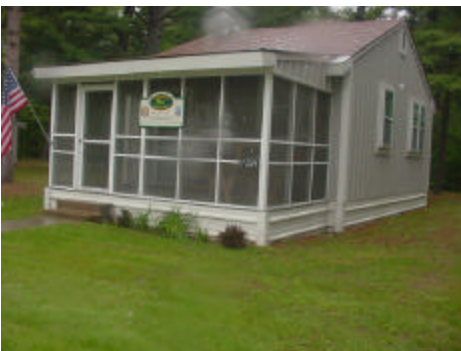
### ***Lodging Building T-2255***

Building T-2255, constructed in 1944, is a single story structure housing a single standard room at 607 square feet. The building is in good condition but does not meet current Army Lodging standards. The cost to make improvements and bring this facility up to Army Lodging standards will exceed the 50% replacement cost.

Our recommendation is to remove building T-2254 from the Lodging inventory, allowing the installation to determine an alternate use for the facility. This facility will be removed from the Fort Drum Wellness Solution and Lodging Master Plan.

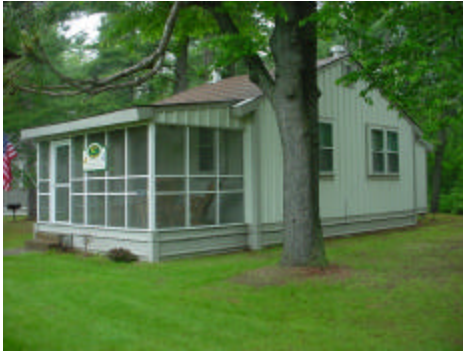
#### ***Lodging Building T-2257***

Building T-2257, constructed in 1944, is a single story structure housing a single standard room at 607 square feet. The building is in fair condition but does not meet current Army Lodging standards. The cost to make improvements and bring this facility up to Army Lodging standards will exceed the 50% replacement cost.

Our recommendation is to remove building T-2257 from the Lodging inventory, allowing the installation to determine an alternate use for the facility. This facility will be removed from the Fort Drum Wellness Solution and Lodging Master Plan.

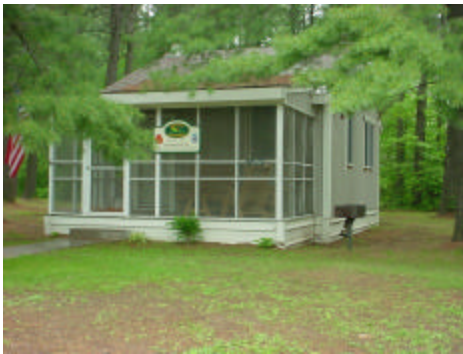
#### ***Lodging Building T-2258***

Building T-2258, constructed in 1944, is a single story structure housing a single standard room at 460 square feet. The building is in fair condition but does not meet current Army Lodging standards. The cost to make improvements and bring this facility up to Army Lodging standards will exceed the 50% replacement cost.

Our recommendation is to remove building T-2258 from the Lodging inventory, allowing the installation to determine an alternate use for the facility. This facility will be removed from the Fort Drum Wellness Solution and Lodging Master Plan.

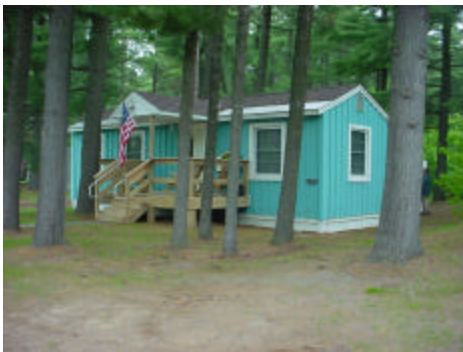
#### ***Lodging Building T-2259***

Building T-2259, constructed in 1944, is a single story structure housing a single standard room at 672 square feet. The building is in fair condition but does not meet current Army Lodging standards. The cost to make improvements and bring this facility up to Army Lodging standards will exceed the 50% replacement cost.

Our recommendation is to remove building T-2259 from the Lodging inventory, allowing the installation to determine an alternate use for the facility. This facility will be removed from the Fort Drum Wellness Solution and Lodging Master Plan.

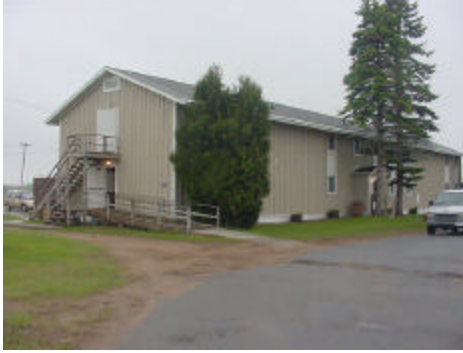
### ***Lodging Building T-2340***

Building T-2340, constructed in 1944, is a 2-story structure housing 13 family suites with a full kitchen at 480 square feet each. The building is in good condition but does not meet current Army Lodging standards. The cost to make improvements and bring this facility up to Army Lodging standards will exceed the 50% replacement cost.

Our recommendation is to remove building T-2340 from the Lodging inventory, allowing the installation to determine an alternate use for the facility. This facility will be removed from the Fort Drum Wellness Solution and Lodging Master Plan.

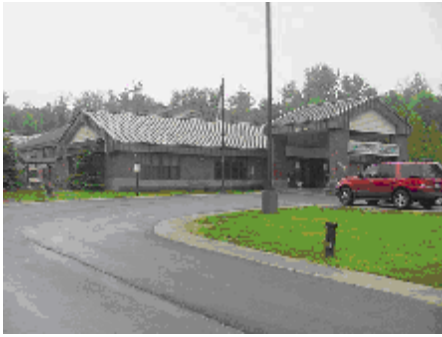
## Building P4205

This building is in good condition for both the Condition Assessment and Function Criteria. In this building the Condition Assessment costs include the wellness items and the Renovation Cost includes functional renovations but not Condition Assessment cost due to the limited nature of the renovation. Therefore in the Cost Analysis the sum of the Condition Assessment and Renovation cost is used for the ratio to the Replacement Cost

Condition Assessment & Renovation Cost	\$1,143,300.00
Replacement Cost	\$10,639,955.00
Condition Assessment to Replacement Cost Ratio	10.75%

Because the Sum of the Condition Assessment and Renovation Costs to Replacement Cost Ratio is less than 50%, repair and continued use of Building P-4205 is recommended.
